Manhole Inspection Summary

Manhole # S55G__040MH

Insp Date: **3/4/09 10:24 AM**

Location Address: **side 200 fagley st**

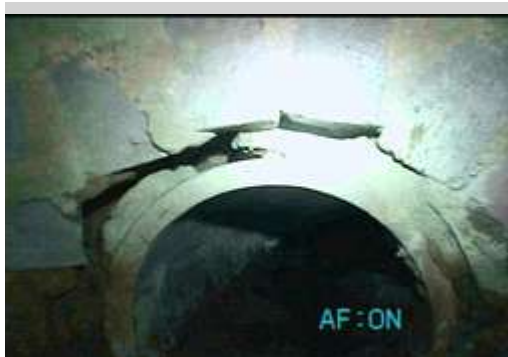
Defect 4

Condition: ☐ Sound ☐ Cracked ☐ Root Intrusion ☐ Loose Brick ☒ Deteriorated

barrel wall deteriorated around pipe connection

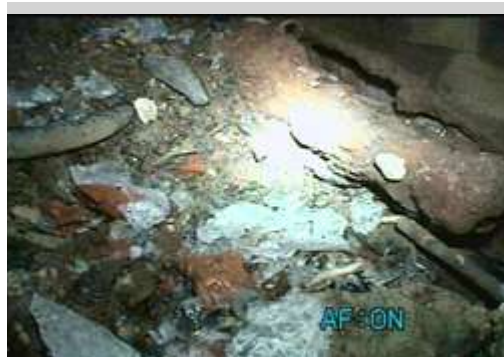
Defect 3

Condition: ☐ Sound ☐ Cracked ☐ Root Intrusion ☐ Deteriorated ☐ Leaks ☒ Debris

channel debris

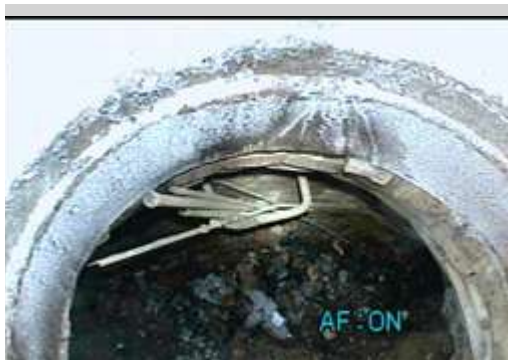
Defect 2

Steps Count: **1** Missing: **0** ☒ Corroded

corr step

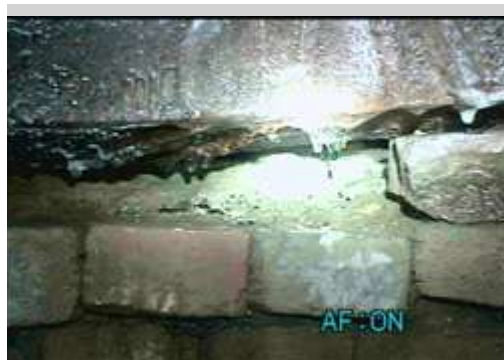
Defect 1

Condition: ☐ Sound ☐ Cracked ☐ Root Intrusion ☒ Loose Brick ☒ Deteriorated

chimney condition deteriorated with loose bricks

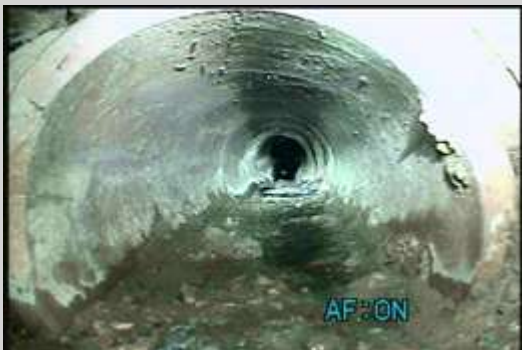
12 O'Clock Outflow

Deposits: ☐ None ☐ Mud ☐ Sludge ☒ **Debris** ☐ Grease

Silt Depth: 2 (in.) Deposits Extent: **Light**

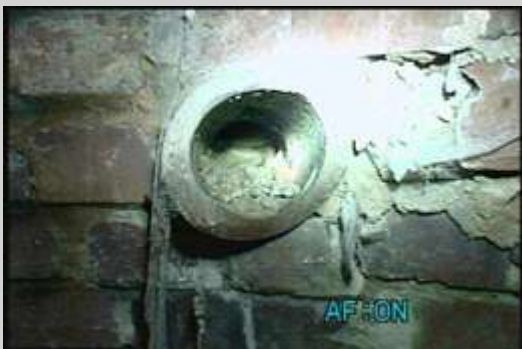
2 O'Clock Inflow

Deposits: ☐ None ☐ Mud ☐ Sludge ☒ **Debris** ☐ Grease

Silt Depth: 2 (in.) Deposits Extent: **Medium**
